National Energy
Board

National Energy Board Safety Advisory

Vibration fatigue failure of piping

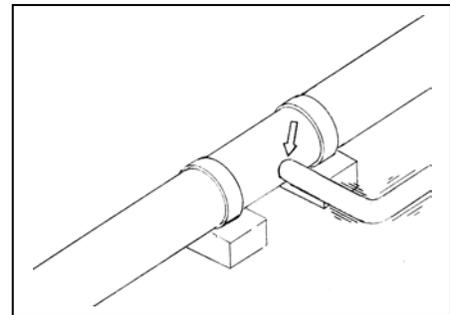
Although vibration fatigue has been deemed to be the immediate cause of all these failures, poor design and lack of effective piping support is considered the basic cause of the incidents. Designs included poor support for the smaller pipe components, sizing (length, diameter and thickness) of the piping itself, and lack of consideration for additional stresses on the pipe-to-pipe junction in situations where a valve or regulator was installed at the remote end of the small diameter pipe. This resulted in bending stresses at the junction being increased to the point of failure.

Vibration levels imparted to the piping adjacent to compressor/pump units should be monitored and managed. Piping configurations potentially at risk such as the one described above, should be investigated and modified to manage any vibration which may impact the pipe and associated junctions.

1. Replacement of inadequately sized components.
 - consider replacing existing piping with that of higher schedule.
 - consider modifying the component altogether such as removing a nipple and installing the valve directly at a weld-o-let, thereby shifting the weight of the valve closer to the compressor/pump unit's discharge piping
2. Additional support of piping.
3. Vibration source attenuation.
